ANNUAL REPORT FOR 2016

Banks School Road Buffer Mitigation Site
Lenoir County
TIP No. R-2719A
COE Action ID: 200511238
DWR Project #: 20050787

Prepared By:
Roadside Environmental Unit & Natural Environment Section
North Carolina Department of Transportation
June 2016

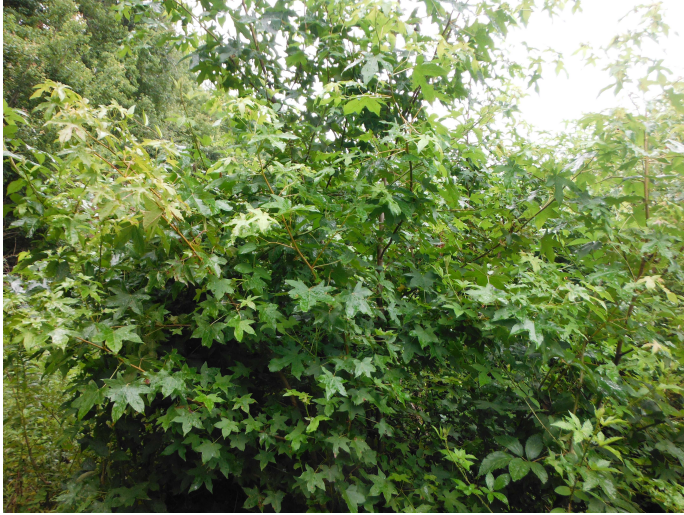
Photo Point #1 looking East at Vegetation Plot #1

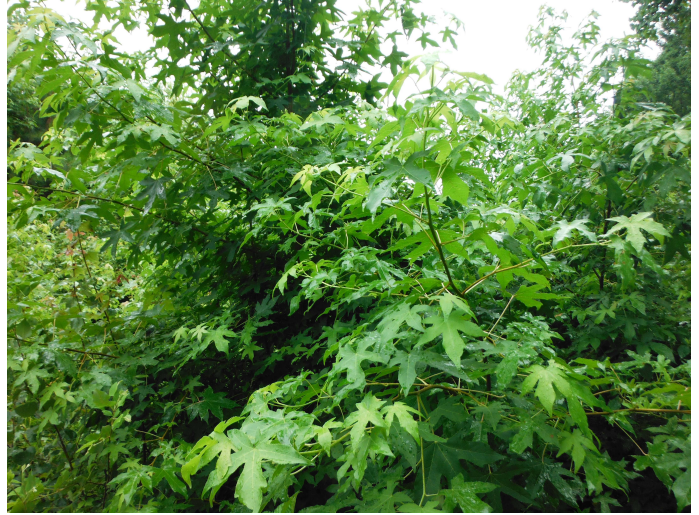
Photo Point #2 looking South

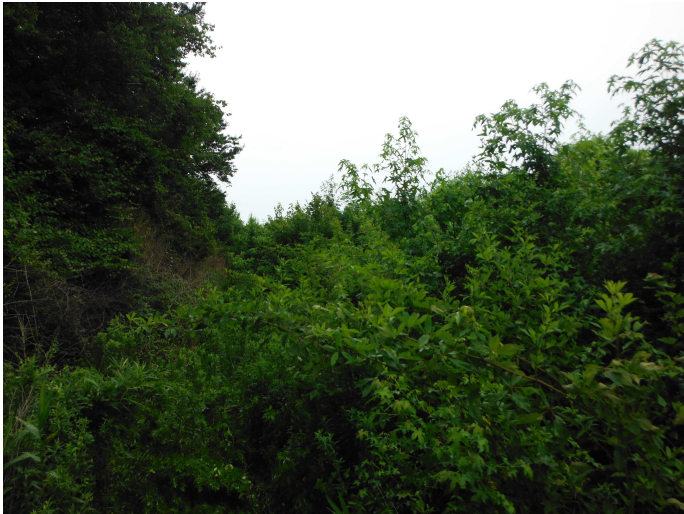
Photo Point #3 looking East at Vegetation Plot #2

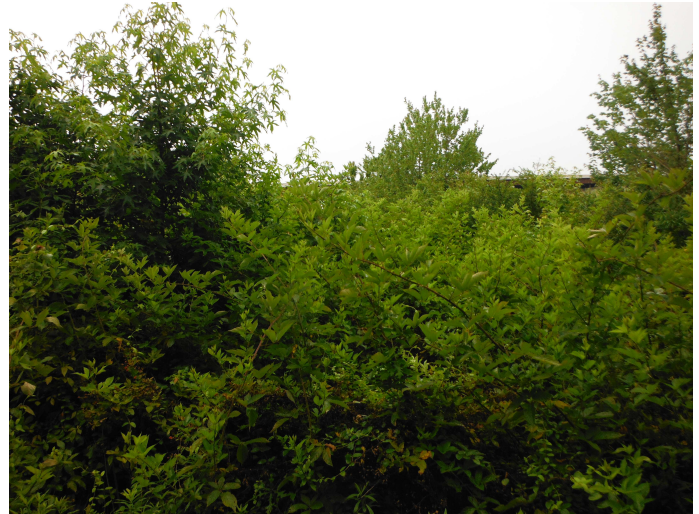
Photo Point #4 looking Southeast toward C.F. Harvey Pkwy

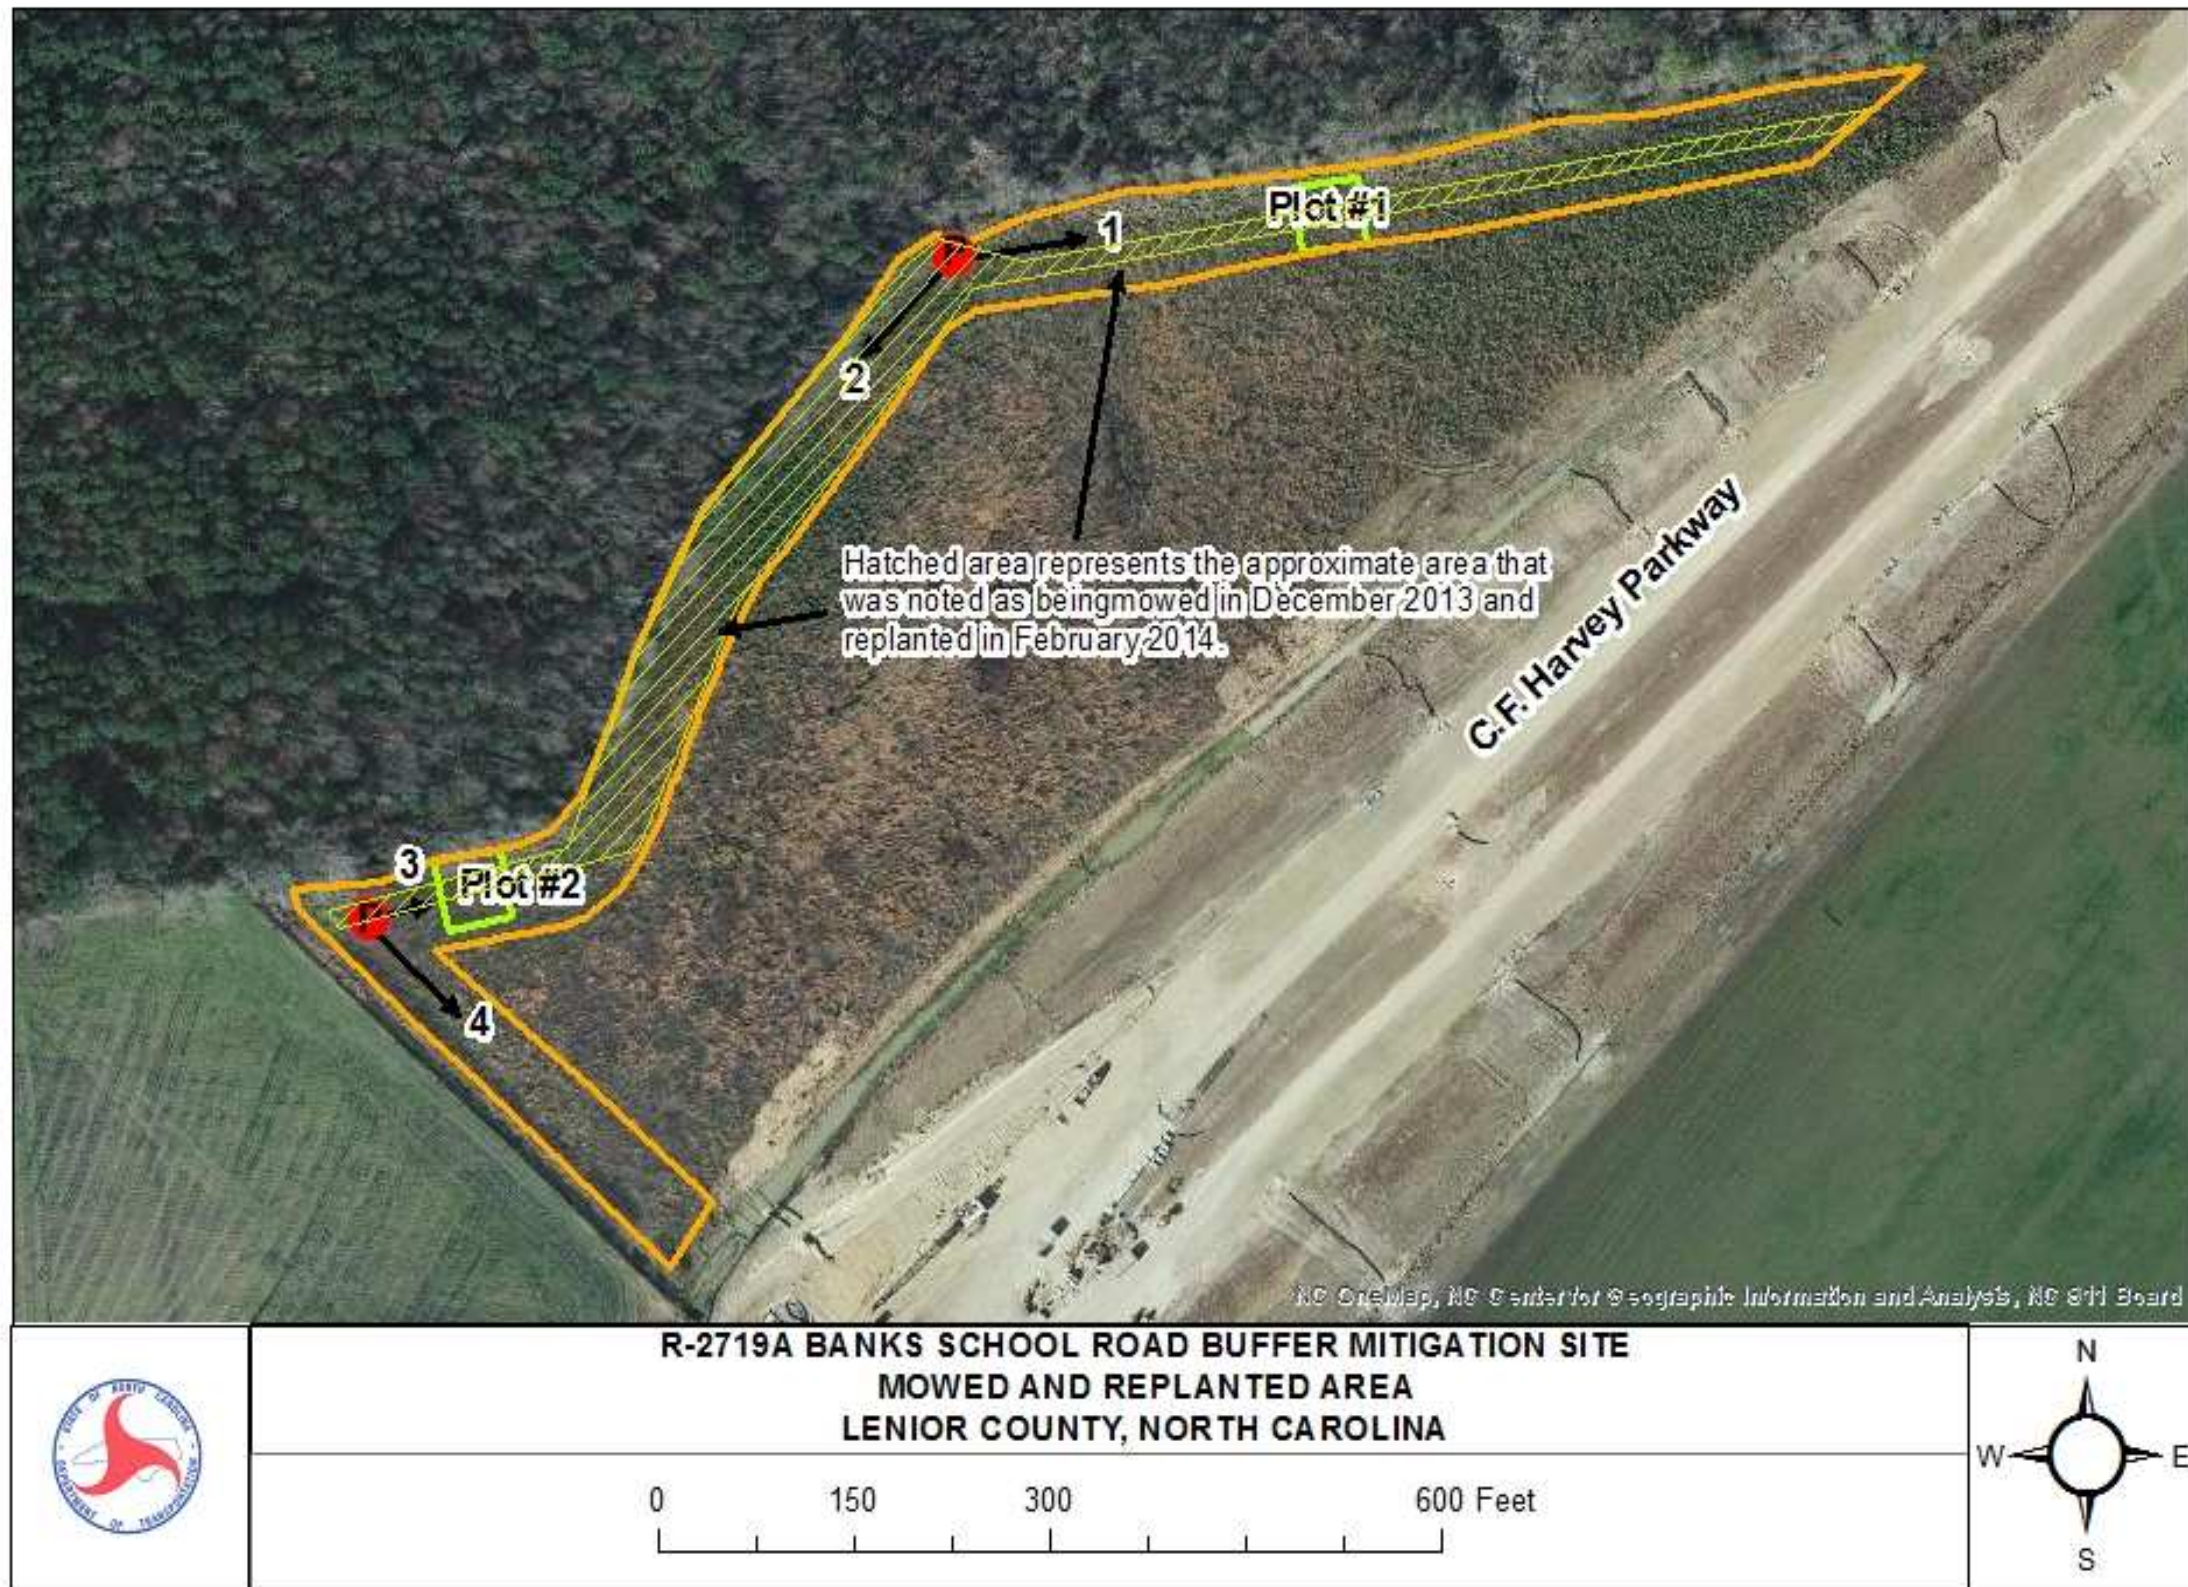
Appendix D. Site Map of Mowed and Replanted Area

In December 2013, NCDOT personnel noted that a portion of the buffer had been mowed. In February 2014, the mowed portion of the buffer was replanted, locks were installed on all gates into the site, and mitigation signs were installed at the site to prevent further encroachments. See Appendix D for site map of mowed and replanted buffer. In September 2015, NCDOT sprayed an herbicide application on the privet noted onsite as requested by NCDWR.
